# **DAM INSPECTION CHECKLIST POSSUM POINT POWER STATION POND ABC**

INSPECTION DATE: DEC. 11, 2015

INSPECTED BY: KALEB ACRE

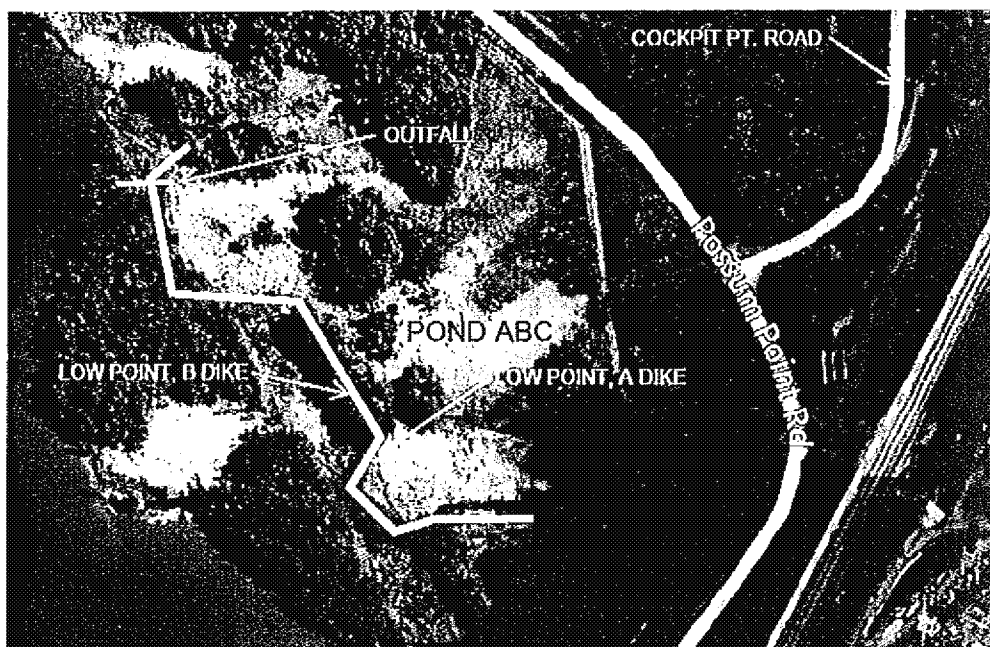
Location/ Condition	(y/n)	Change (y/n)	Comments
Low Point, A dike*			
Flow	N	N	2:52 PM NO STANDING WATER BEHIND SANDBAGS
Erosion	N	N	SANDBAGS & RIPRAP IN PLACE, WITH SEVERAL SANDBAGS RIPPED OPEN
Low Point, B dike*			
Flow	N	N	2:52 PM NO STANDING WATER BEHIND SANDBAGS
Erosion	N	N	SANDBAGS & RIPRAP IN PLACE, WITH SEVERAL SANDBAGS THAT HAVE BEEN IMPACTED & TORN OPEN
Outfall water surface El. (top of stoplogs to water)			1:34 PM WEIR IS DRY AND THERE IS NO STANDING WATER AGAINST WEIR OR SANDBAGS, SAND BAGS ARE IN PLACE WITH SEVERAL BAGS BEING RIPPED OPEN. <del>ADDITIONAL</del> GLOVER IS PUMPING WATER FROM POND C AND THROUGH FILTER SYSTEM, STANDING WATER AT TOE OF EMBANKMENT AT POND C.

Additional Comments (Note any changes observed along the embankment crest or downstream slope observed from the crest.): STANDING WATER AT TOP OF EMBANKMENT AT INTERSECTION OF PONDS B & C, STANDING WATER AT TOE OF EMBANKMENT IN POND A, STANDING & CHANNELIZED WATER WITHIN POND B

(TYPICAL FROM HOIST)

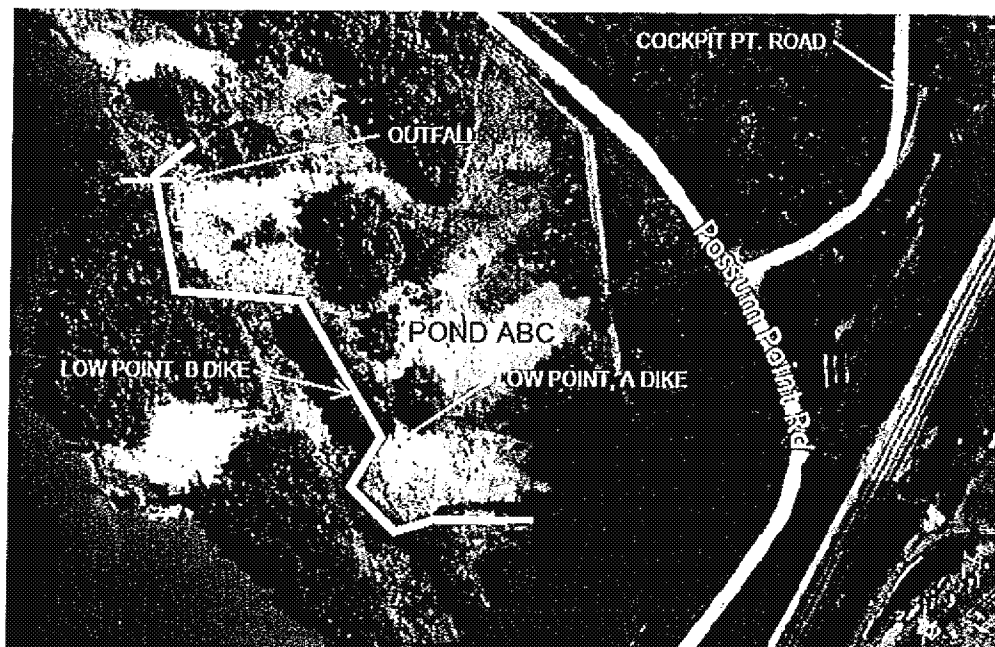
Location/ Condition	(y/n)	Change (y/n)	Comments
Low Point, A dike*			
Flow	N	N	09:30 NO STANDING WATER AGAINST SAND BAGS & SAND BAGS & RIP RAP IN PLACE
Erosion	N	N	SEVERAL BAGS RIPPED
Low Point, B dike*			
Flow	N	N	09:35 NO STANDING AT SAND BAGS & SAND BAGS IN PLACE
Erosion	N	N	WITH A FEW RIPPED BAGS
Outfall			
water surface El. (top of stoplogs to water)			- 09:42 NO STANDING WATER AT SAND BAGS, SEVERAL RIPPED SAND BAGS - NO WATER AGAINST WEIR & WEIR IS DRY

- STANDING WATER ON EMBANKMENT BETWEEN PONDS B & C
- STANDING WATER AGAINST POND A/B/C EMBANKMENTS (TYP. THROUGHOUT)

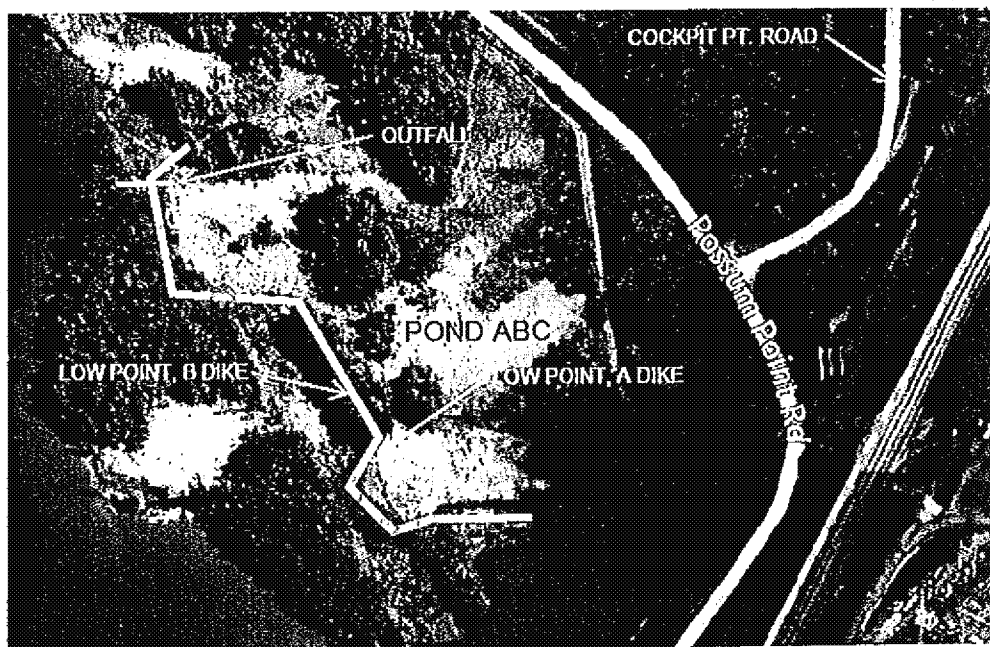
Location/ Condition	(y/n)	Change (y/n)	Comments
Low Point, A dike*			
Flow	N	N	1259 - NO STANDING WATER AGAINST SAND BAGS, SAND BAGS MISS PLACED OR IMPACTED WITH NUMEROUS BAGS THAT HAVE BEEN RIPPED OPEN, BAGS COVER RIP RAP AND SEVERAL SAND BAGS WERE HAVE FALLEN OVER HILL, RIP RAP STILL IN PLACE
Erosion	N	N	
Low Point, B dike*			
Flow	N	N	1254 - NO STANDING WATER AGAINST SANDBAGS, SAND BAGS ARE IN PLACE WITH A FEW RIPPED BAGS
Erosion	X N KMA	X N KMA	EROSION OF SOIL HALF-WAY DOWN LENGTH OF SAND BAGS, POCKET ABOUT 3 FT WIDE & 2 FT LONG AND 11 B/W BAGS & POND B
Outfall			
water surface El. (top of stoplogs to water)			1237 - NO STANDING WATER A WIER, SAND BAGS HAVE NO STANDING WATER AGAINST THEM, THE SAND BAGS ARE A BIT MIS PLACED, BUT STILL EFFECTIVE & BAGS ARE RIPPED, SEVERAL BAGS

Additional Comments (Note any changes observed along the embankment crest or downstream slope observed from the crest.): - STANDING WATER AT TOP OF EMBANKMENT BETWEEN PONDS B & C

- STANDING WATER AT TOE OF EMBANKMENT AT PONDS C, B/A

- EMBANKMENT ROAD LOOKS TO HAVE HAD A PIECE OF EQUIPMENT TRAVEL ACROSS IT, WHICH HAS IMPACTED SAND BAGS AT LOW POINTS OF DIKE

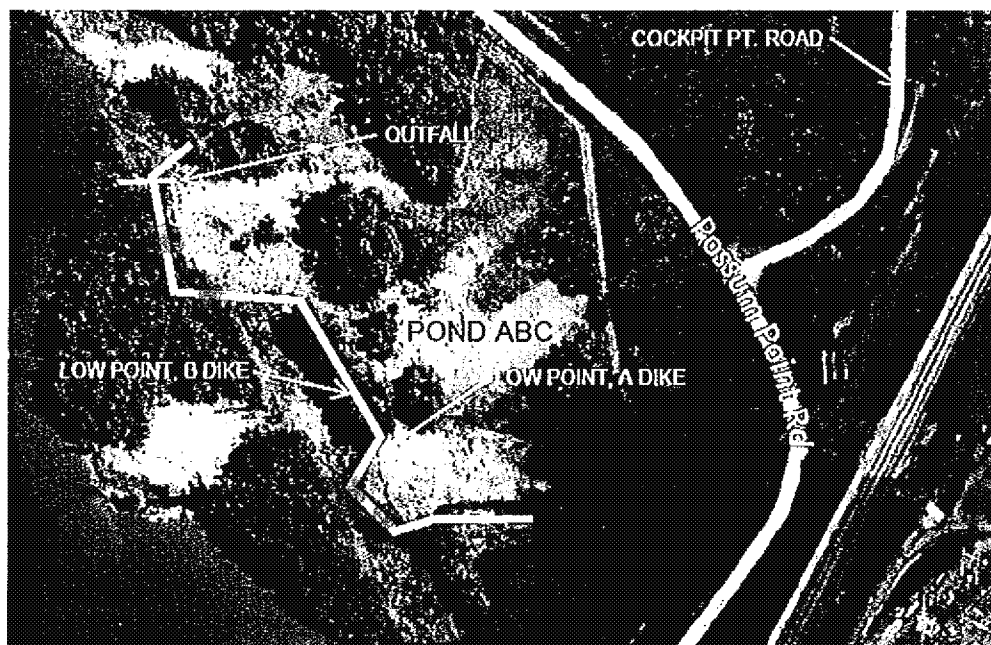
Location/ Condition	(y/n)	Change (y/n)	Comments
Low Point, A dike*			
Flow	N	N	
Erosion	N	N	
Low Point, B dike*			
Flow	N	N	
Erosion	N	N	TREE REMOVAL INSIDE OF SANDBAG-BERM
Outfall			
water surface El. (top of stoplogs to water)			NO STANDING WATER

**Additional Comments (Note any changes observed along the embankment crest or downstream slope observed from the crest.):** 1) DAMAGED SANDBAG-BERM @ LOW POINT A, REPORTED 12/22/15 REPAIRED. 2) NO EROSION AS REPORTED ON 12/22. TREE REMOVAL POCKET. 3) AREAS NOTED BELOW W/ STANDING WATER.
